# NATIONAL TRANSPORTATION SAFETY BOARD

# **Locomotive Event Recorders**

# Group Chairman's Factual Report By Cassandra Johnson

NTSB Number: HWY18MH005

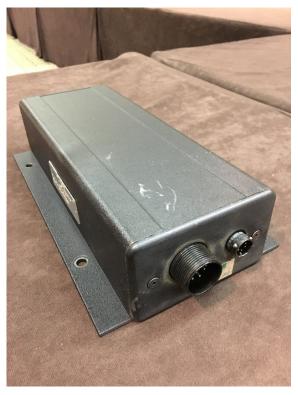
Figure 1. Photo of Amtrak 145's locomotive event recorder.

Amtrak 145's locomotive event recorder was undamaged as shown in figure 1. On February 1, 2018, the locomotive event recorder was reinstalled into Amtrak 145 and using Amtrak's download cables and software, was successfully downloaded as shown in figure 2.
